Use of Dilatometer in Unusual Difficult Soils – a Case Study

2 VUKOVAR HIGH SCHOOL BUILDING

3 SMALL EARTH DAM EMBANKMENT- THE SECOND CASE

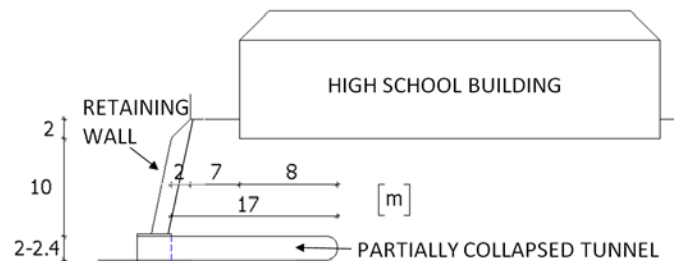
Fig. 2. Schematic cross-section of high school building with position of collapsed tunnels.

Wetting and softening of the foundation soil did not affect the whole object equally, and the most affected area was the south-eastern part of the object under which several tunnels were positioned (Fig. 1. and Fig. 2.).

The tunnel vaults under the building (see the cross-section presented in the Fig. 2.) made of loess became wet because the tunnel served as a drain for the excess water in the soil. Gradually they started to collapse causing the additional soil settlement under the structure. It was therefore decided to fill the tunnels with concrete.

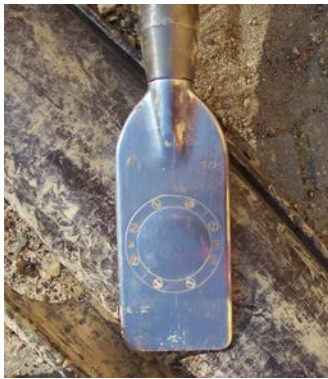
Fig. 4. Dilatometer blade after retrieval from borehole of stiff loess.

It is, however, valuable to point out that dilatometer blade worked very well, despite hammering. There are two ways to perform dilatometer tests with drilling rig of limited pushing force: (1) it is possible to work with pre-drilling for some depth intervals (say 1-1,5 m) and then perform consecutive dilatometer tests over the limited depth interval (say 1-1,2 m), or (2) one can force blade by hammering as long as it progresses. In this latter case one should be aware of need for the blade reparation. Therefore, two blades should be at the site, in order to keep the work going well in time (the authors experienced this at some other projects too, like in the case of testing sand deposits under one embankment in Eastern Croatia). When undisturbed samples are unavailable, and/or when rig doesn't have enough pushing power, hammering of the dilatometer blade can be performed, under the condition that constant control of blade functionality and integrity of electronics in it is checked.

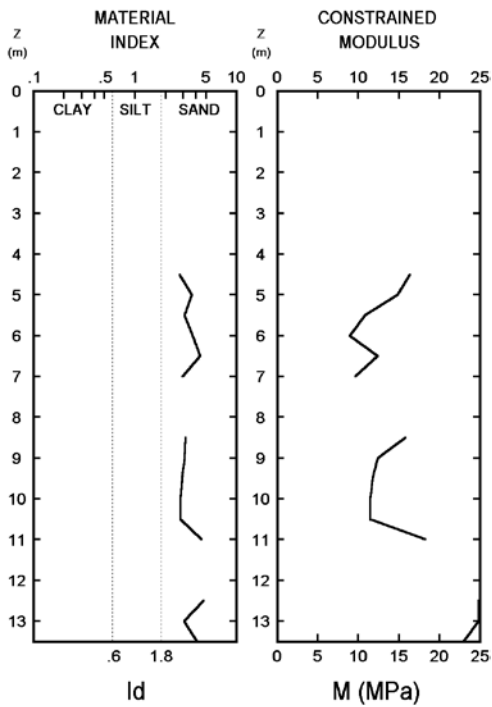
Fig. 5. Dilatometer test results: distribution of material index and constrained modulus with depth.

Comparison of values of the constrained modulus obtained by dilatometer test with oedometer modulus values from other nearby boreholes is presented on Fig. 6. Reasonably good fit of data can be noticed. In terms of soil type identification (Table 1) it can be seen that dilatometer recognized coherent material (ML/CL, Fig. 6.) as sandy or silty - sandy soil.

If only this description would have been used in designing jet grouting work it would have led to the wrong grouting set up. Therefore, check of dilatometer interpretation with findings from classical drilling records is highly recommended in non-standard soils.

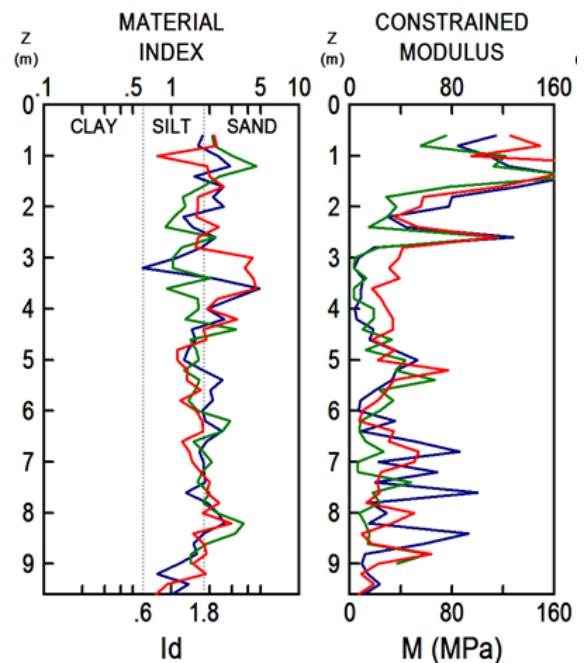
Fig. 10. Distribution of DMT material index and constrained modulus with depth for positions M1 (blue), M2 (green) and M3 (red).

In terms of soil type interpretation, DMT test interpreted clay soil as sandy-silty to silty-sandy soil type, with very rare clayey-silty thin layers as it can be seen in Fig. 10. Therefore there were almost no data for undrained strength in DMT interpretation. According to Marchetti (1980), in DMT test for clay soil material index I_d it should be $0.1 < I_d < 0.6$. Since the value of I_d in compacted clay of the dam was found to be about or higher than 2 (suggesting a sandy or sandy-silty soil type) and there was no in situ pore pressure in soil, it could be concluded that p_0 was too small, due to structure of compacted soil and absence of in situ pore pressures.

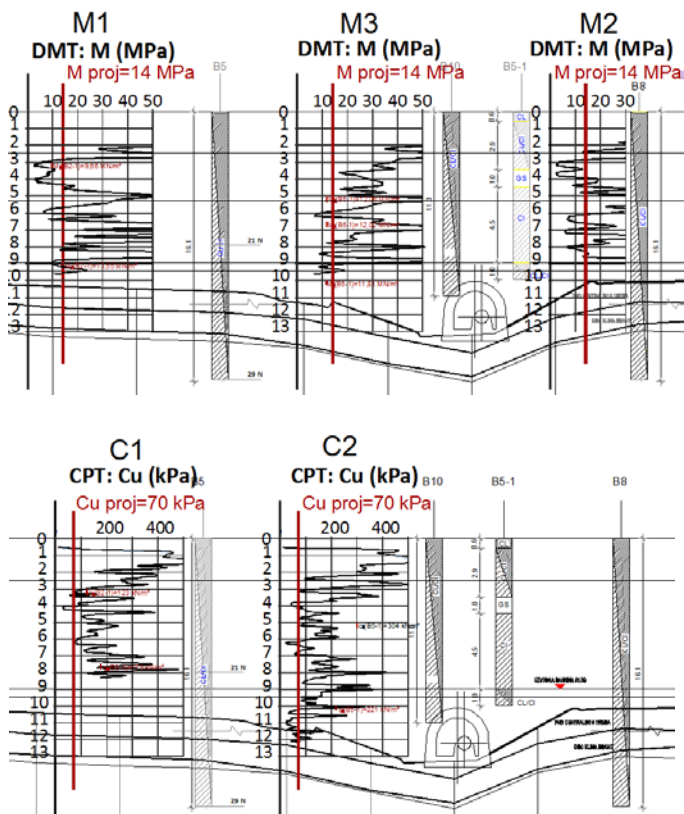
Fig. 11. DMT (M1, M2, M3) and CPT tests (C1, C2), over the dam height (cross-section along the crest).

Fig. 11 shows values of modulus of vertical deformation as interpreted from DMT tests compared to design required values, and undrained shear strength as interpreted from CPT test compared to design required values. Both, CPT and DMT tests detected very pronounced inhomogeneity in the clay embankment – it seems that almost every lift of compacted clay can be distinguished from the penetration test results.

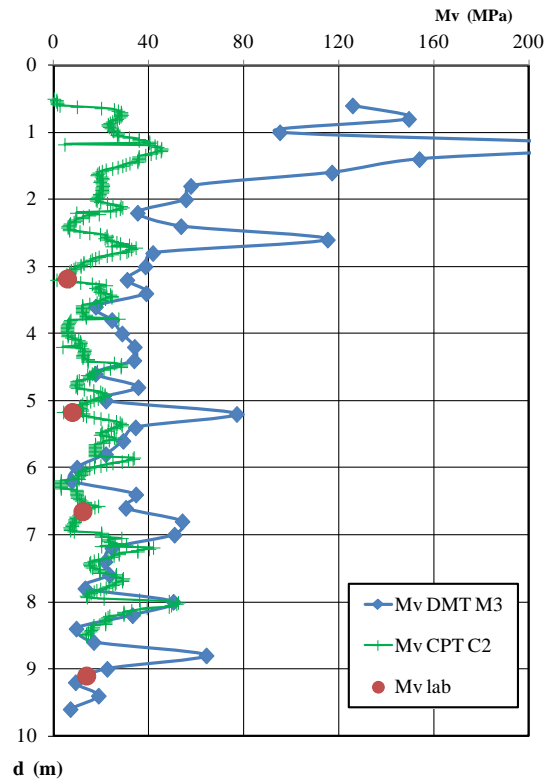
Fig. 12. Modulus of vertical deformation from oedometer (on submerged specimens), CPT interpretation, compared to DMT standard interpretation values (performed on clay layers that were not submerged).

Comparison of modulus of vertical deformation was made for relevant results for oedometer, CPT and DMT test. For CPT it seems that the value of modulus is two times greater than the oedometer modulus, and the values of M_v from DMT test were the highest of these three (Fig. 12.). This might be due to the fact that oedometer tests were performed on submerged specimens, and CPT and DMT tests were performed on clay fill in the embankment that was not submerged.

The comparison as shown in Fig. 12 can only be used as a guide for correcting in situ evaluated parameters to laboratory values, but even then correction would not be constant with depth.

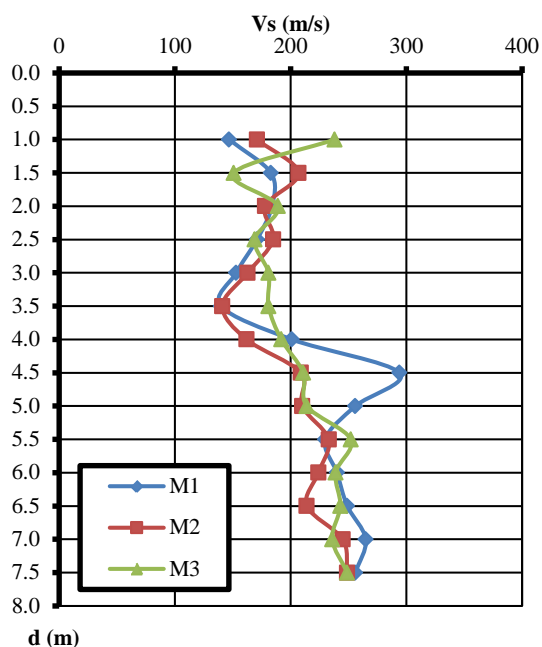
Fig. 14. Measured shear wave velocity at different SDMT locations, depth intervals 0,5 m.

Tests marked as M1, M2 and M3 (DMT-tests) were performed in one run as standard tests and seismic tests (SDMT), using a seismic probe as described in Cavallaro et al. (2006). Fig. 14. shows shear wave velocities measured in 0,5-meter depth intervals. Since a shear wave velocity is a „measure“ of soil structure and its rigidity, variability of those two parameters should be regarded as a basic indication of the variability of soil mechanical properties. These variabilities are less pronounced in wave velocity diagrams than in CPT and DMT standard diagrams, probably due to difference in depth interval of interpretation: 0,5 m for seismic test compared to depth interval of 0,2 m for static DMT. Although velocities generally increase with depth, there are weaker and stronger intervals at certain depths in M2 and M1 boreholes. The M3 location shows constant increase in shear wave velocity by depth.
