Use of Dilatometer in Unusual Difficult Soils – a Case Study

ABSTRACT: Dilatometer tests were performed on two construction sites in eastern Croatia in unusual soils. First site was the building on a hard loess soil that suffered from settlements caused by soil wetting. It was necessary to find out about soil stiffness in order to design soil improvement by use of jet grouting. The second site was an earth dam that had to be checked for in homogeneity in clay fill mechanical properties, in connection with rehabilitation of the dam. In both cases knowledge of soil stiffness was important, and dilatometer tests were performed in addition to other test methods (in situ and laboratory), so that comparison of evaluated value of soil modulus of vertical deformation was possible. Also, hard loess soil required dilatometer blade to be hammered in order to penetrate at certain intervals of depth, which in turn required careful and repeated reparation of the instrument. Despite these difficulties instrument worked well. Comparison of soil parameters evaluated from dilatometer measurements with parameters obtained by other in situ and laboratory tests showed that dilatometer is useful and re

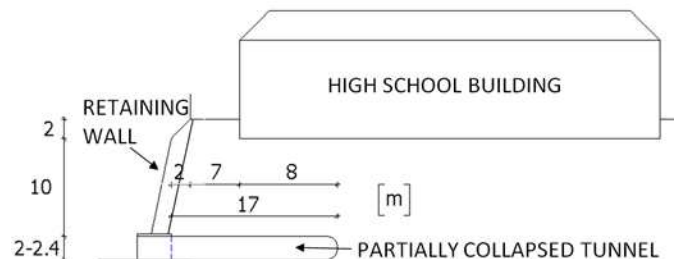
Fig. 2. Schematic cross-section of high school building with position of collapsed tunnels.

Wetting and softening of the foundation soil did not affect the whole object equally, and the most affected area was the south-eastern part of the object under which several tunnels were positioned (Fig. 1. and Fig. 2.).

The tunnel vaults under the building (see the cross-section presented in the Fig. 2.) made of loess became wet because the tunnel served as a drain for the excess water in the soil. Gradually they started to collapse causing the additional soil settlement under the structure. It was therefore decided to fill the tunnels with concrete.

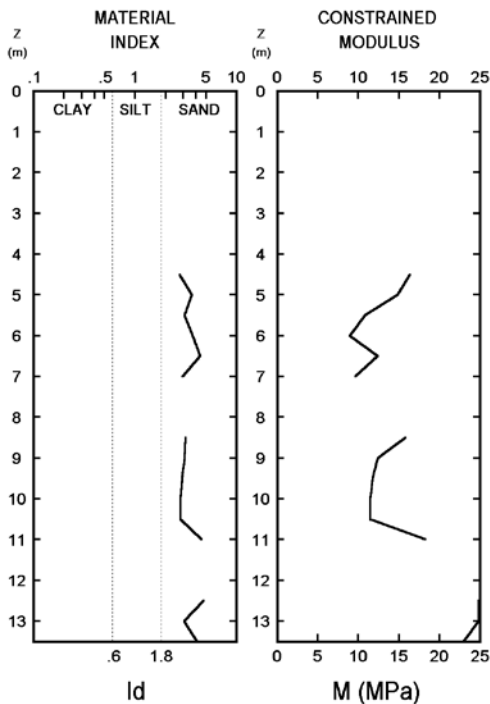
Fig. 5. Dilatometer test results: distribution of material index and constrained modulus with depth.

Comparison of values of the constrained modulus obtained by dilatometer test with oedometer modulus values from other nearby boreholes is presented on Fig. 6. Reasonably good fit of data can be noticed. In terms of soil type identification (Table 1) it can be seen that dilatometer recognized coherent material (ML/CL, Fig. 6.) as sandy or silty - sandy soil.

If only this description would have been used in designing jet grouting work it would have led to the wrong grouting set up. Therefore, check of dilatometer interpretation with findings from classical drilling records is highly recommended in non-standard soils.

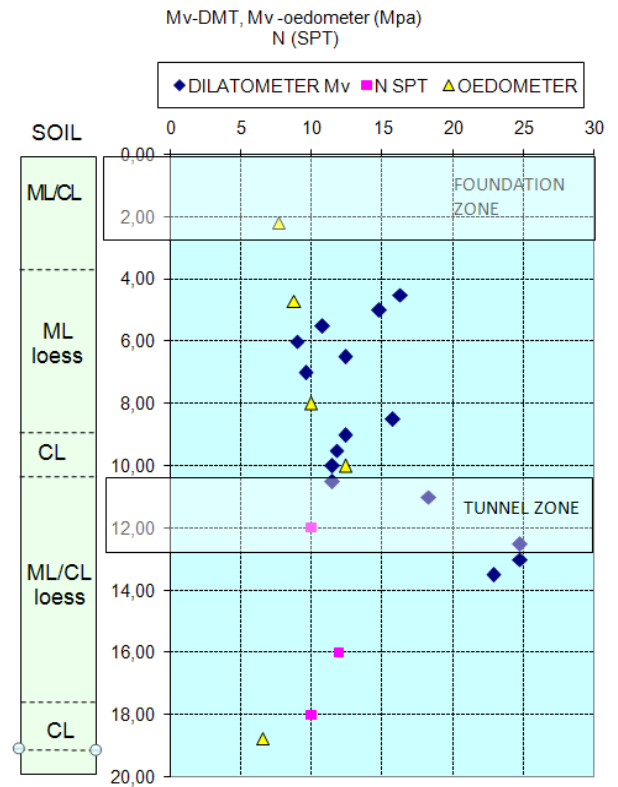
Fig. 6. Soil profile and modulus of vertical deformation.

The exploration works have revealed the zone of increased moisture content in the soil right beneath the foundation, to the depth between 9 – 11 meters. This fact provoked collapse of the loess structure, which has been confirmed by the oedometer tests.

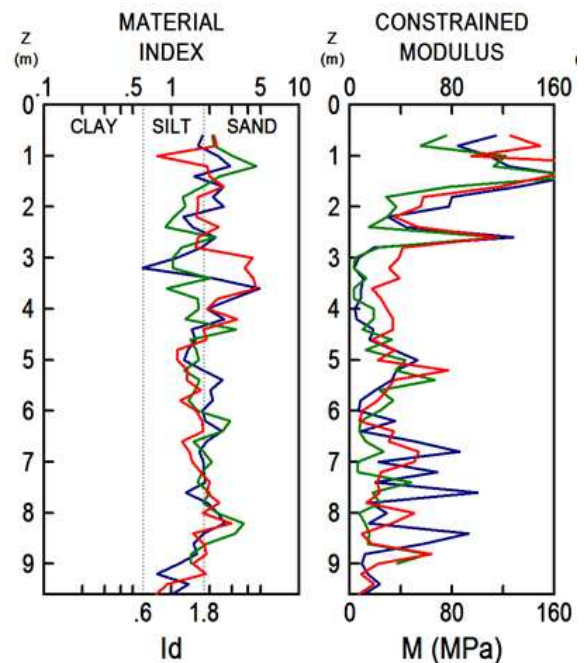
Fig. 10. Distribution of DMT material index and constrained modulus with depth for positions M1 (blue), M2 (green) and M3 (red).

In terms of soil type interpretation, DMT test interpreted clay soil as sandy-silty to silty-sandy soil type, with very rare clayey-silty thin layers as it can be seen in Fig. 10. Therefore there were almost no data for undrained strength in DMT interpretation. According to Marchetti (1980), in DMT test for clay soil material index I_d it should be $0.1 < I_d < 0.6$. Since the value of I_d in compacted clay of the dam was found to be about or higher than 2 (suggesting a sandy or sandy-silty soil type) and there was no in situ pore pressure in soil, it could be concluded that p_0 was too small, due to structure of compacted soil and absence of in situ pore pressures.

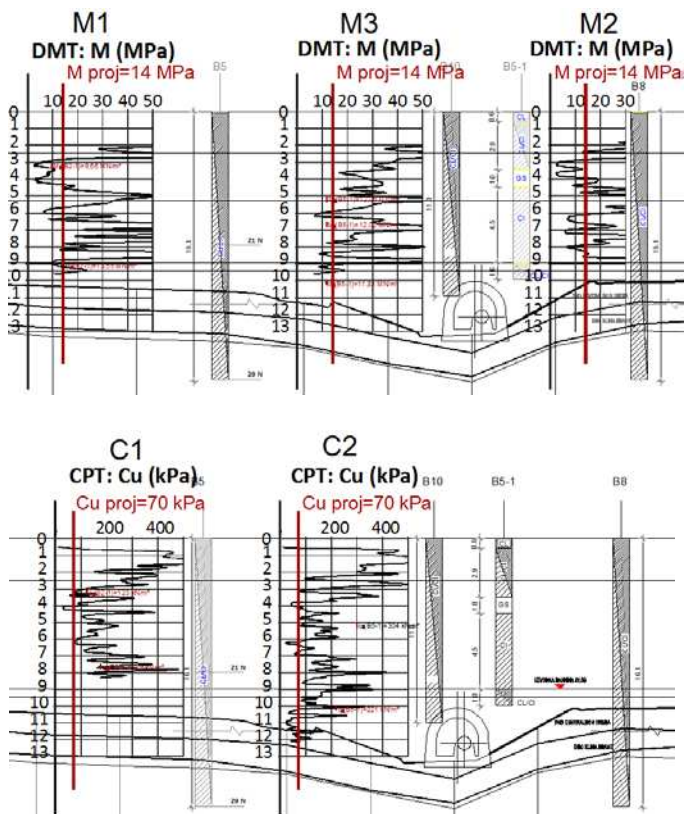
Fig. 11. DMT (M1, M2, M3) and CPT tests (C1, C2), over the dam height (cross-section along the crest).

Fig. 11 shows values of modulus of vertical deformation as interpreted from DMT tests compared to design required values, and undrained shear strength as interpreted from CPT test compared to design required values. Both, CPT and DMT tests detected very pronounced inhomogeneity in the clay embankment – it seems that almost every lift of compacted clay can be distinguished from the penetration test results.

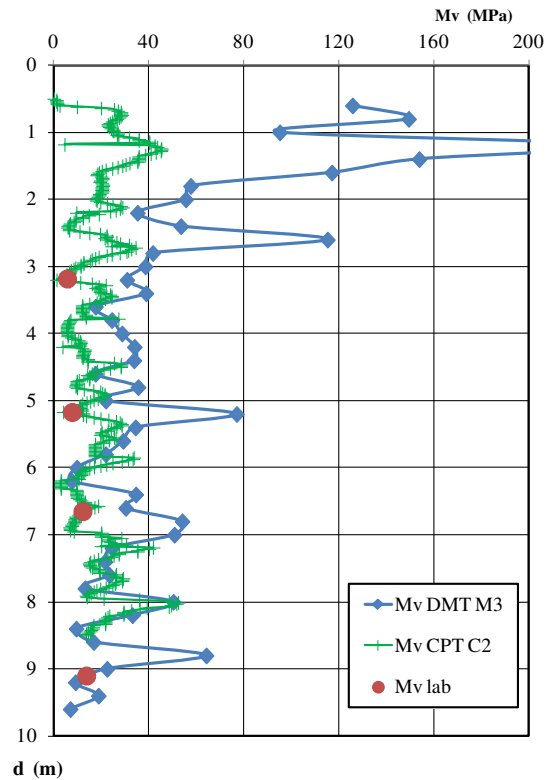
Fig. 12. Modulus of vertical deformation from oedometer (on submerged specimens), CPT interpretation, compared to DMT standard interpretation values (performed on clay layers that were not submerged).

Comparison of modulus of vertical deformation was made for relevant results for oedometer, CPT and DMT test. For CPT it seems that the value of modulus is two times greater than the oedometer modulus, and the values of M_v from DMT test were the highest of these three (Fig. 12.). This might be due to the fact that oedometer tests were performed on submerged specimens, and CPT and DMT tests were performed on clay fill in the embankment that was not submerged.

The comparison as shown in Fig. 12 can only be used as a guide for correcting in situ evaluated parameters to laboratory values, but even then correction would not be constant with depth.

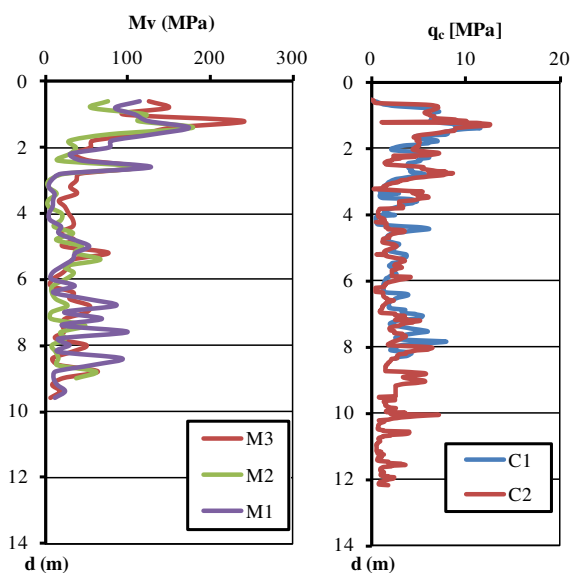
Fig. 13. CPT and DMT tests in cumulative presentation.

Fig. 13. shows that CPT and DMT tests on different locations gave similar mechanical properties of the compacted clay with depth.

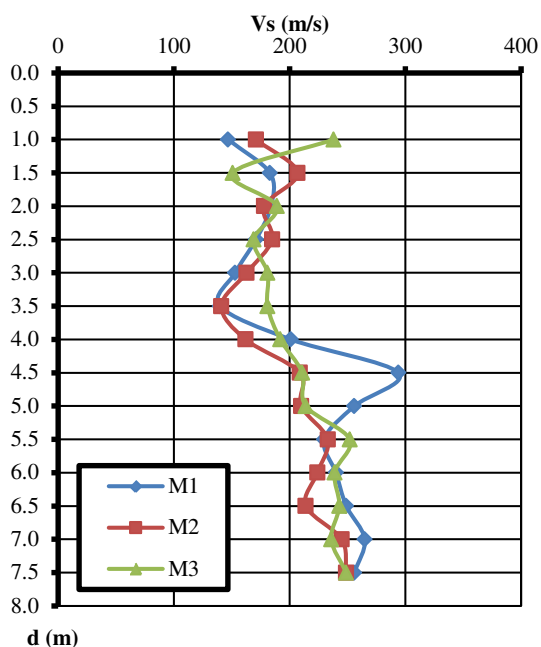
Fig. 14. Measured shear wave velocity at different SDMT locations, depth intervals 0,5 m.

Tests marked as M1, M2 and M3 (DMT-tests) were performed in one run as standard tests and seismic tests (SDMT), using a seismic probe as described in Cavallaro et al. (2006). Fig. 14. shows shear wave velocities measured in 0,5-meter depth intervals. Since a shear wave velocity is a „measure“ of soil structure and its rigidity, variability of those two parameters should be regarded as a basic indication of the variability of soil mechanical properties. These variabilities are less pronounced in wave velocity diagrams than in CPT and DMT standard diagrams, probably due to difference in depth interval of interpretation: 0,5 m for seismic test compared to depth interval of 0,2 m for static DMT. Although velocities generally increase with depth, there are weaker and stronger intervals at certain depths in M2 and M1 boreholes. The M3 location shows constant increase in shear wave velocity by depth.
