The Use of a DMT to Monitor the Stability of the Slopes of a Clay Exploitation Pit in the Boom Clay in Belgium

Herman Peiffer

Ghent University, Zwijnaarde, Belgium. E-mail: herman.peiffer@ugent.be

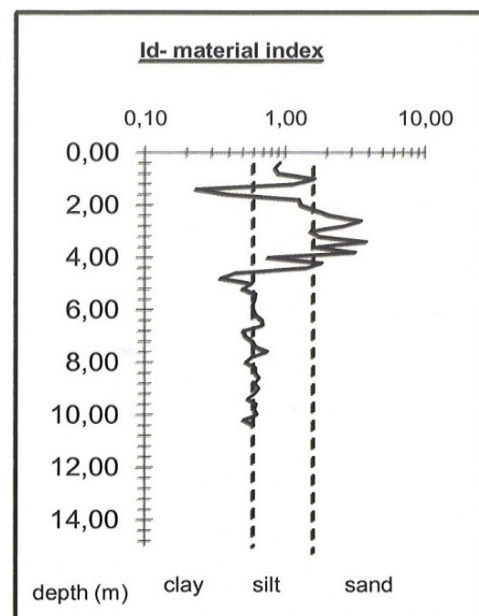
Fig.1. I_d (DMT1).

Based on the geological investigations and the geological data map, the upper layer consists out of a sandy silt (quaternary deposit). Under this layer the tertiary overconsolidated Boom Clay can be found. This can be seen also on the I_D -diagram as presented in Fig. 1.

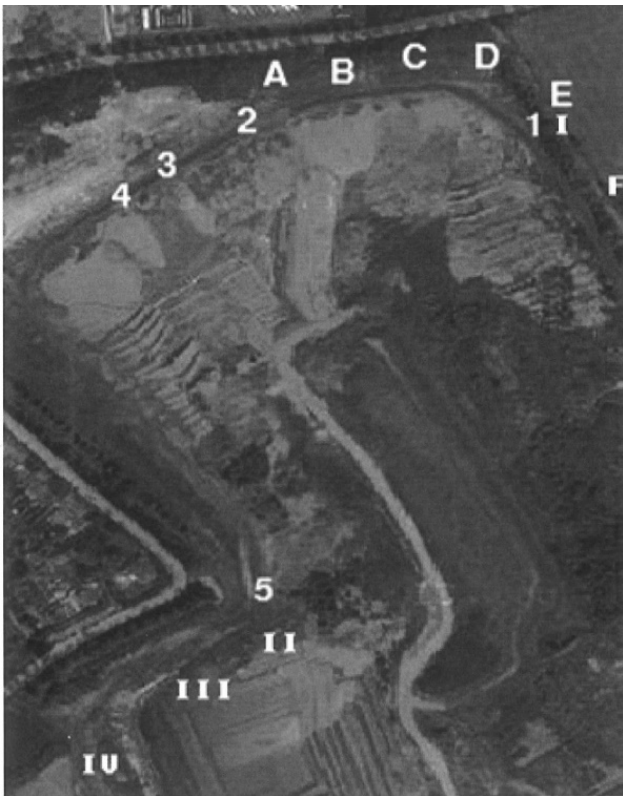
Fig. 2. Photo view of the site.

In the Fig. 2 (Photo View) and 3 (Map) an overview of the site and the DMT-tests is presented.

- January 2014 – DMT 1 to 5 (before the important sliding)
- July 2014 – DMT A to F (about 1 month after the sliding)
- January 2015 – DMT I to IV (after stabilizing)

In the second half of 2013 a more important slide occurred in the neighborhood of point 5 on figure 2. The number 5 refers to DMT 5 executed in the beginning of 2014 at a distance of 5 m from the top of the slope.

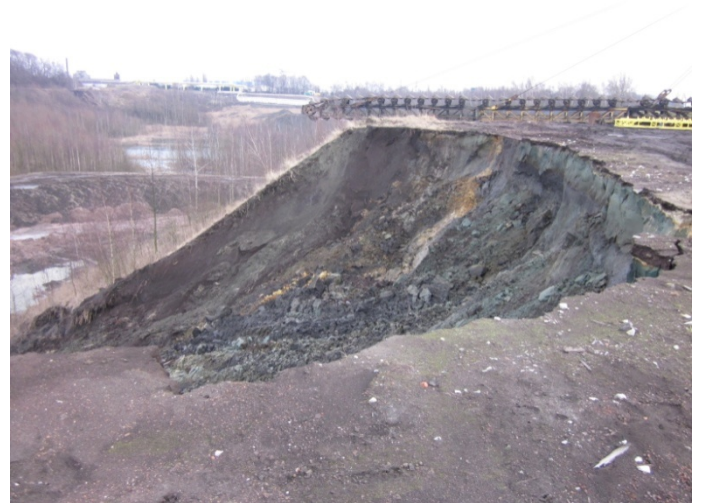
Fig. 6. Photo of the unstable zone after sliding.

In the figure 6 a photo of the slide is presented.

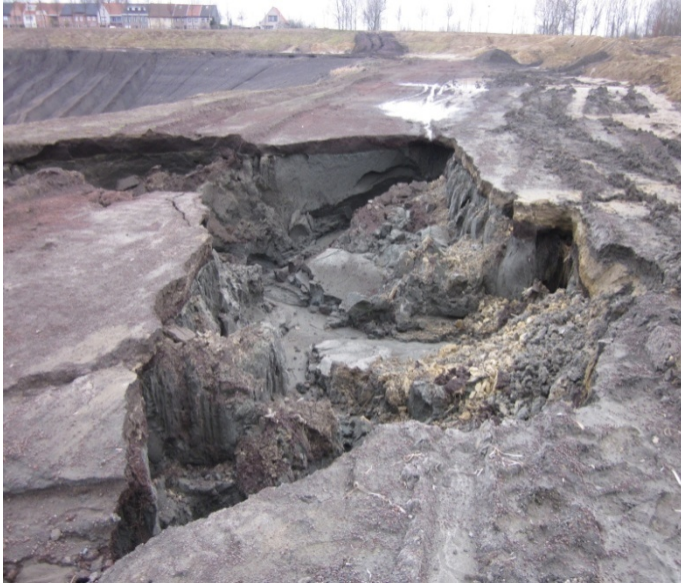
Fig. 8. Sliding mass (June 2014).

In June 2014 an important sliding occurred (area of about 100 m x 50 m) between DMT 1 and DMT 2

The extent of the affected zone can be seen on the Fig. 8 and 9. Two profiles are presented in the Fig.

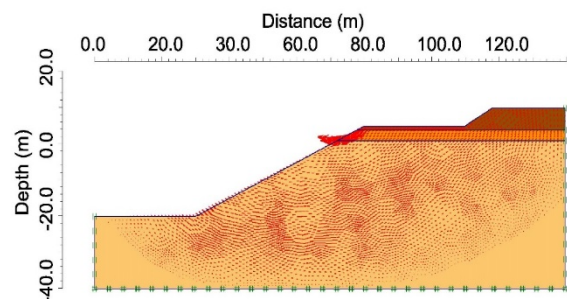
Fig. 14. PLAXIS-analysis.

The analysis resulted in a design where a deep drain has to be installed at a depth of 5 m., as shown in the Fig. 15 and 16. This drain was installed at the

After the installation of this drain, there was an immediate effect on the depth of the groundwater. The original depth of 1,5 m increased to a depth of about 4.5 m. The safety of the slope stability increased from 0,9 to 1.31.

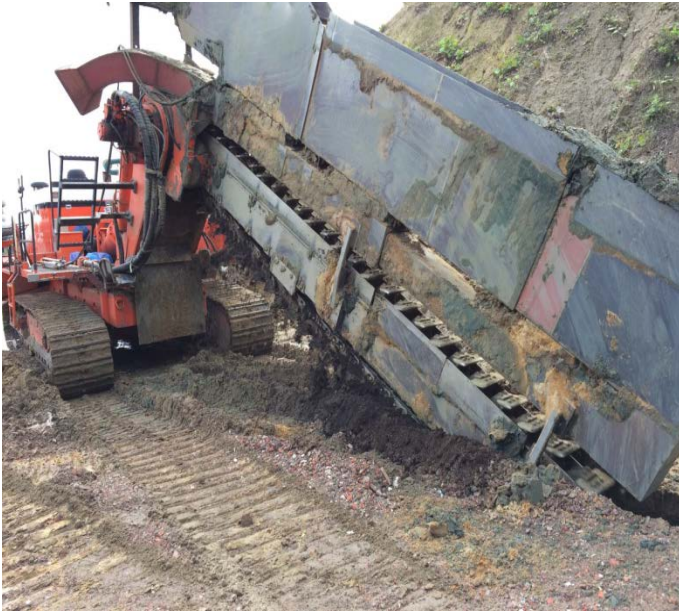
Fig. 15. Installation of the deep drainage.

beginning of November 2015. The red line in figure 15 is the position of the drain in plan view.
