Use of Dilatometer in Unusual Difficult Soils – a Case Study

2 VUKOVAR HIGH SCHOOL BUILDING

3 SMALL EARTH DAM EMBANKMENT- THE SECOND CASE

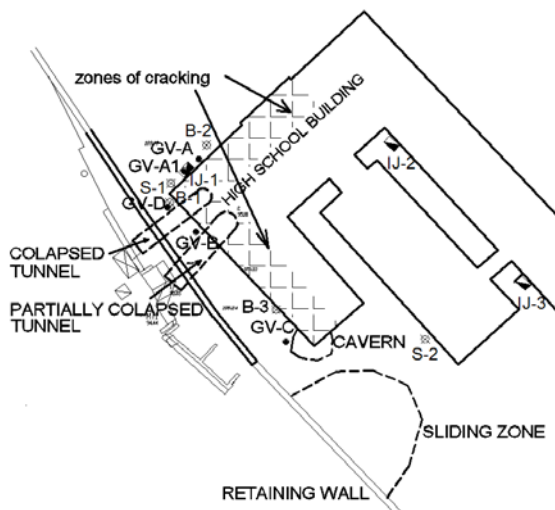
Fig. 1. Disposition of boreholes, inclinometer and deformer holes, along the area of the building (boreholes: B-1, B-2, B-3, S-1, S-2, IJ-1, IJ-2, IJ-3, deformers: GV-A, GV-B, GV-D, inclinometers: GV-C, GV-D).

Wetting and softening of the foundation soil did not affect the whole object equally, and the most affected area was the south-eastern part of the object under which several tunnels were positioned (Fig. 1. and Fig. 2.).

In one exploration borehole (named GV-B, Fig. 1.) dilatometer test was employed. Pre-boring was made to the depth of 4 m to get under the foundation base level. Dilatometer measurements were made from the 4,5 m to 13,5 m depth in intervals of 0,5m. The interval of 0,5 m was chosen for practical reasons. The pushing machine didn't have large pushing power (less than 2 t) and pre-boring to clean the borehole above test depth at several intervals was necessary. Three consecutive measurements were made by pushing dilatometer blade (in total depth interval of 1,5 m), then the borehole needed to be cleaned. Dilatometer blade was hammered by vibration of drilling machine rotary head into the soil for the last measurement before cleaning the borehole. After several intervals of hammering, the dilatometer probe needed to be repaired, because electrical contact cable inside the blade detached from its position and needed to be soldered back. The preparation of dilatometer borehole GV-B is shown in Fig. 3. and the dilatometer blade after retrieval from the borehole after measurement is shown at Fig. 4. Dilatometer test results are presented in Table 1 (material index with soil description, dilatometer and constrained modulus, and the friction angle) and in Fig. 5. (material index and constrained modulus).

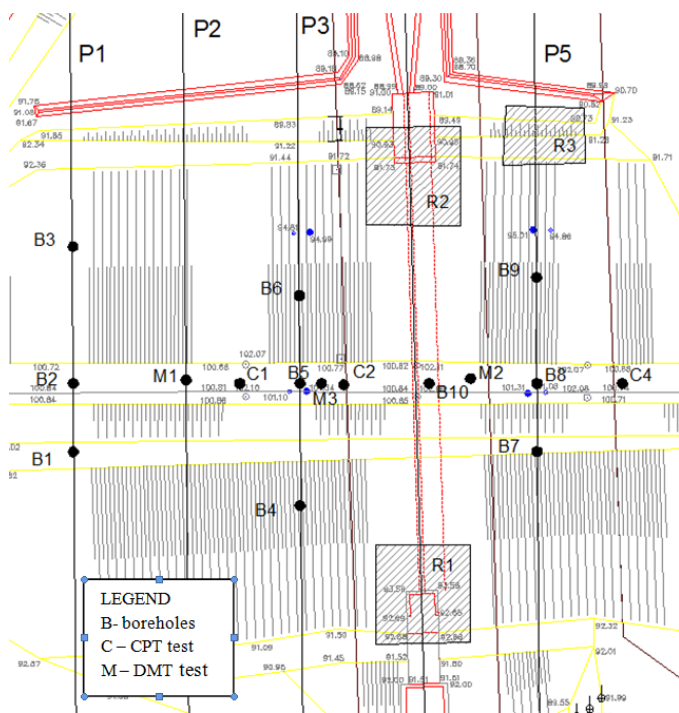
The site testing program consisted of drilling of boreholes to get samples for a laboratory testing of the clay, cone penetration testing (CPT) and a dilatometer testing (DMT). The results of analysis of clay properties in the dam based on CPT, DMT and laboratory testing are presented in this section. Boreholes were positioned over the dam body and penetration tests were performed in the crest, see Fig. 9. (Elektroprojekt Zagreb 2010).

Fig. 9. Position of in situ tests and boreholes on the dam; most important work was done on the crest (line B2-C4).

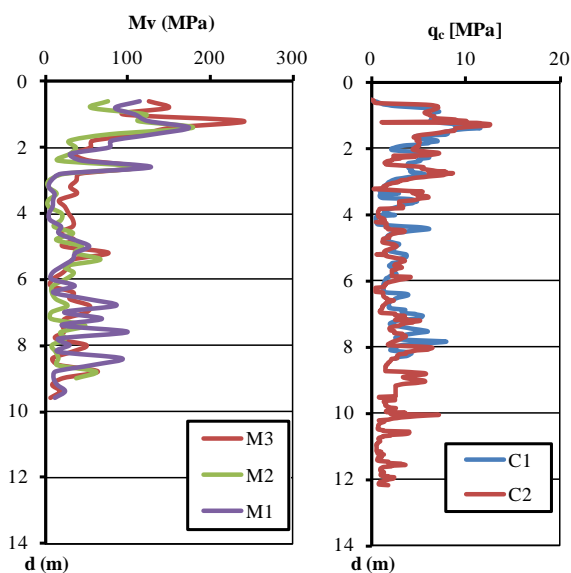
Fig. 13. shows that CPT and DMT tests on different locations gave similar mechanical properties of the compacted clay with depth.

Fig. 13. CPT and DMT tests in cumulative presentation.
